IIC REPORT

General Communication Corporation, N455A; DHC-3T; Aleknagik, Alaska; August 9, 2010

ALL INFORMATION HEREIN IS PRELIMINARY IN NATURE

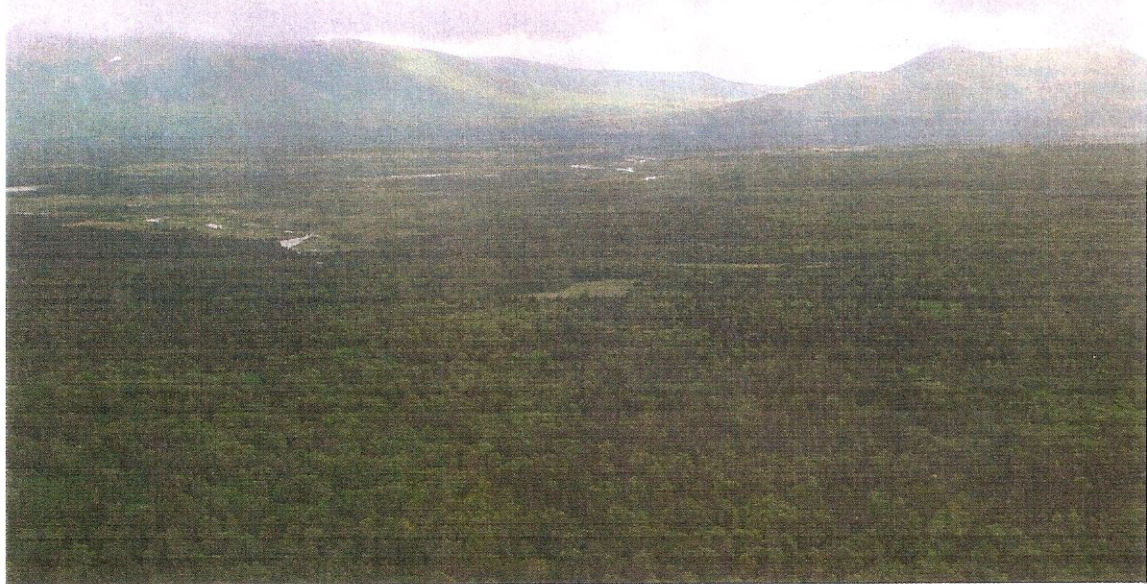
The site was to the left (east) of the flight aircraft's expected flight path, entering a pass between the Muklung Hills and an unnamed peak of 1,351 feet in height. The topographic map showed the floor of the pass to be slightly less than 400 feet MSL. The tundra between Lake Nerka and the pass was about 100 feet msl. The altitude of the wreckage was 900-1000 feet msl, according to both a USGS topographic map and reference to a handheld GPS altimeter. Two Muklung Hill peaks in front of the airplane were shown on the topographic map to be 2,309 feet and 2,170 feet in elevation; an aviation sectional map showed the Muklung Hills peak to be 2550 feet msl.
